HOSPITAL - AIR HANDLER FAN WHEEL SHAFT REPAIR WITH BELZONA

CUSTOMER
Florida

APPLICATION DATE
01/15/2021

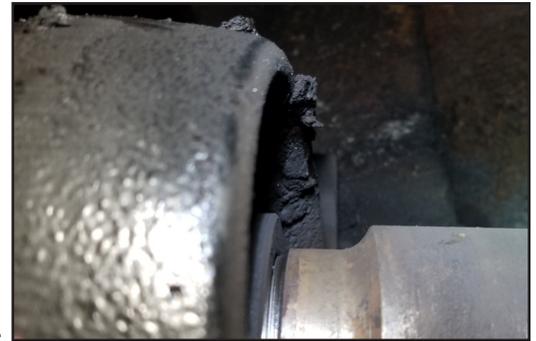
APPLICATION SITUATION
Air handler pillow bearing ceased and galled a 1/8" groove into the air handler fan wheel shaft.

1. Shaft damage
2. Shaft surface prepared
3. 3D former in place
4. New bearing in place
