DAMAGED CONVEYOR BELT RESCUED BY BELZONA.

Quarry in the Midwestern US

Scored conveyor belt on a screen separator

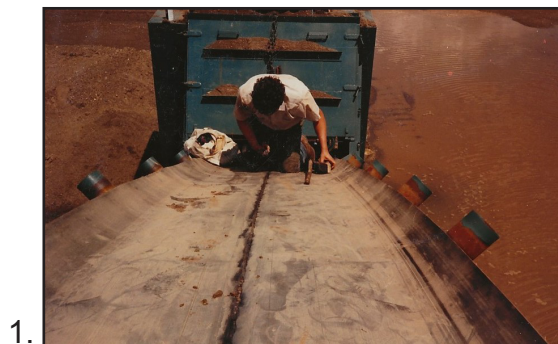
1. Undercutting and roughening the repair area
2. Conditioning with Belzona 2911
3. Applying Belzona 2111 to fill the gouge.
4. A piece, cut from the retired belt showing Belzona 2111 fully intact

The belt was cleaned of dirt and sand. The gouged area was undercut using a utility knife and roughened using a hand roughing brush. Then it was cleaned, using a rag LIGHTLY moistened with Belzona 9111. Belzona 2911 was applied using a cut-back brush. Belzona 2111 was mixed and applied to fill the gouge.

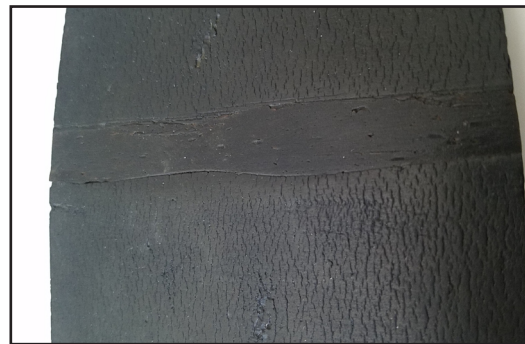
4.

The Belzona repair was a fraction of the cost of a new belt. On a visit to this customer some 6-7 years later he said he had recently replaced the belt as it was severely worn by the countless tons of material passed over it. When asked about the Belzona repair he said it had held up well and pointed to a rolled up belt in some weeds. He allowed the removal of a piece of the old belt where it had been repaired with Belzona 2111.(see photo 4) It is now a prized sales aid. The longevity of the repair can be attributed to the excellence of Belzona 2111 and the diligence applied in prep. As you can see in the photos, the repair was begun in the afternoon and completed after the sun had set.
