BELZONA COMPOSITE FERRY WRAP

Ferry Pipe

Suffering from external corrosion

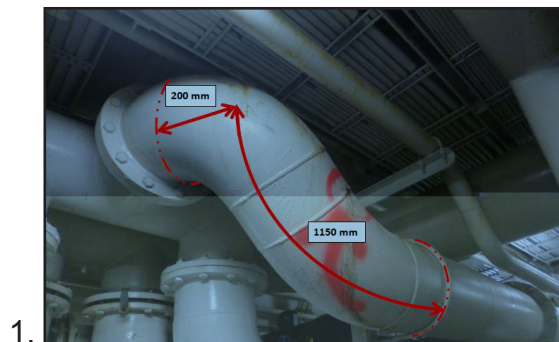
1. Damaged pipe
2. Belzona 1121 wrap in progress
3. Composite Wrap complete
4. Completed application
