CYCLONE COATING PROTECTION WITH BELZONA

Slovakia, starch factory

Damaged cyclone

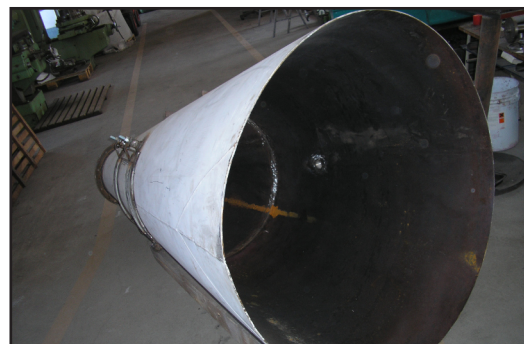
Milled corn material suffers and also adheres on the cyclone surface.

1. Ready for repair
2. Belzona 1812 application
3. Belzona 1812 application detail
