BELZONA PUMP SEATING REPAIR

Slovakia, metallurgic plant

2014

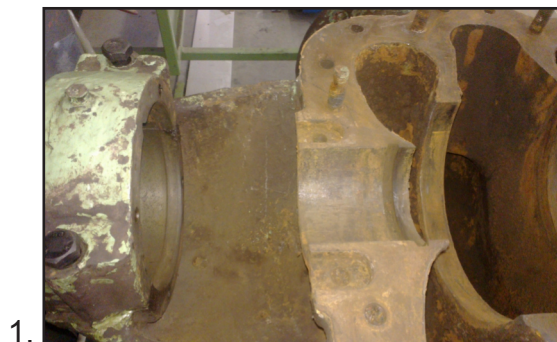
After long time operation the pump has worn down seating. Result is a big clearance of the bearing.

Corrosion, mechanical damage

1. Damaged pump seating
2. Machining of the Belzona 1111
3. Ready for customer
