## BELZONA BACKHOE BUSH HOUSING REPAIR

Backhoe Bush Housings

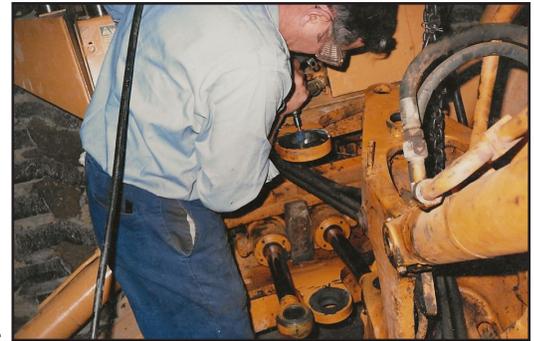
1. Preparation of the worn housings by grinding
2. New bushings grouted in and alignment rod in place
3. The cracked boom which resulted from hitting an underpass

Application was carried out in accordance with Belzona Know-How System Leaflet MPT-07. The worn housings were degreased, ground to produce a rough profile and degreased again. Release Agent was applied to the OD of new bushings and allowed to dry. Belzona 1111 was mixed and applied to both the prepared housings and onto the new bushings, on top of the release agent. The bushings were inserted into the housings and a steel rod, exactly the size of the bushing ID, was run through both bushings to provide alignment. The repair was allowed to cure overnight. Next morning the machine was reassembled, the owner picked it up and it was digging later that day.

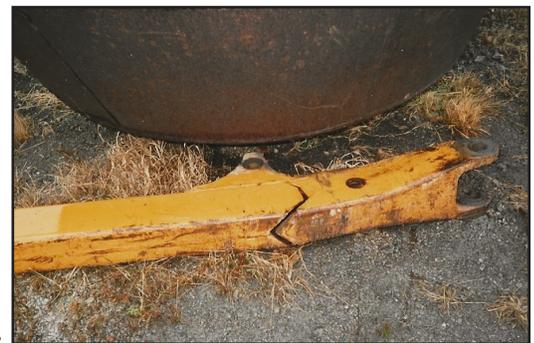
3.

The owner was delighted that the backhoe was only out of service one day, as opposed to two or more for welding and line-boring, as this shop had done for him in the past. The cost of the Belzona repair was a fraction of the welding approach and the machine required minimal disassembly. This repair was followed for over 5 years with no problems. During that time, the boom was cracked when it hit a low underpass while the machine was being transported. The Belzona 1111 repair remained intact. (see photo #3)
