GENERATOR-SIDE COVER WEAR TACKLED WITH BELZONA

A steel cover at a hydropower station, which sits on the generator side of the turbine.

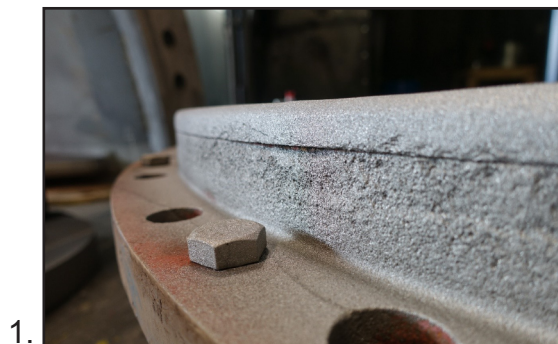
The flat surface of the cover, where the turbine guide vanes are mounted, was very heavily worn. Additionally, the outer diameter of the cover had worn, becoming very uneven and losing up to 5cm of thickness.

1. Damaged edge after blasting
2. Damaged cover face after blasting
3. Edge repaired with Belzona 1331
4. Application completed and machined to fit

The application was carried out in accordance with a modified version of Belzona Know-How System Leaflet VPF-1. The surface was prepared by grit blasting to a near white metal finish and a surface profile of 90 microns. The outer diameter of the cover was rebuilt using Belzona 1311 to create an even and concentric finish. The face of the cover was then coated with Belzona 1331 up to a thickness of 3mm. Finally, both the Belzona 1311 and Belzona 1331 were inspected, touch ups were applied to remove small air pockets, and the surface was machined to the required dimensions and finish.
