HEAT EXCHANGER EMERGENCY REPAIR WITH BELZONA SUPERWRAP II

APPLICATION SITUATION
Heat Exchanger flange at a local food plant was leaking heavily.

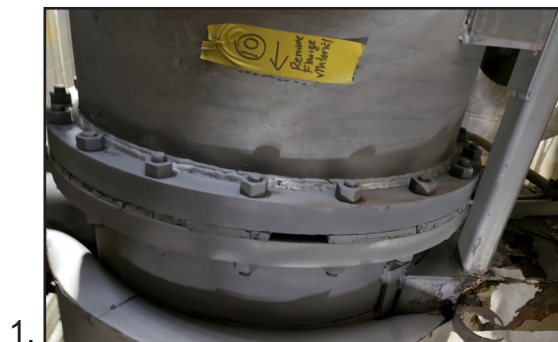
1. Grit Blasted Flange
2. 1511 HT Packed into flange and encapsulated entire circumference.
3. Heat Exchanger Flange wrapped with Superwrap II and consolidation film.
4. Final Product after 48 hour cure.

APPLICATION METHOD
Grit Blasted Flange, then the flange was packed in with Belzona 1511 applied over entire repair area, filling any voids. Applied Belzona 1983 resin to the surface and then started the wrap with Belzona Superwrap II.
