BELZONA TANK BASE SEALING SYSTEM APPLIED TO NITROGEN TANK

Elevated nitrogen storage tank

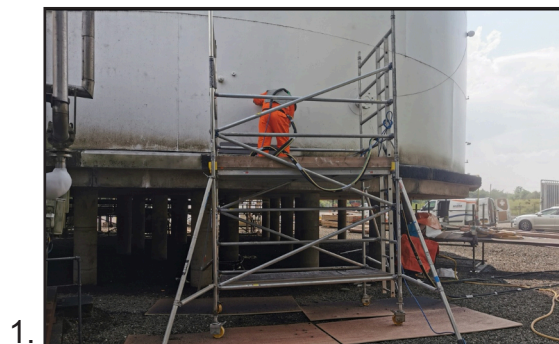
The tank had developed a void between its annular ring and plinth substrate. The asset owner had concerns that if the void had been left to deteriorate, adverse weather conditions and moisture/condensation would accumulate and track under the base of the tank. This would inevitably lead to corrosion of the tank base, leakage or even a tank failure.

1. 15m diameter tank to be repaired
2. Belzona 4131 being applied
3. Tank base sealing system in progress
4. Completed application

Once the substrate has been prepared to a standard of minimum surface profile of 75µm and a surface cleanliness of SA 2.5, Belzona Technosol applicators rebuilt the damaged areas under the annular ring using Belzona 4131 to a 45° fillet which will encourage water flow away from the tank. Once complete the Belzona Tank Base Sealing system was applied in accordance with Know-How system leaflet GSS-03 using Belzona 3131 at a 500mm wide band around the complete circumference.
