BELZONA 3121 (MR7) SEALS AGAINST WATER INGRESS ON FOOD MIXERS

Food Flavourings Manufacturer - UK

Jun-21

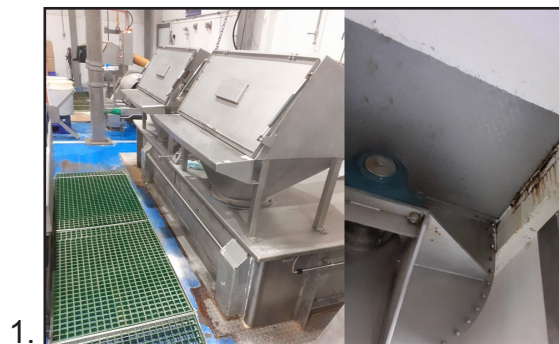
Attempts at an effective seal that could be broken and resealed again had been unsuccessful. During wash-down water would sometimes leak on to the floor below and spoil the final product. The existing seal would be periodically replaced and this procedure took many hours to complete as the seal had to be fully removed and replaced. The time taken to replace the seal was problematic for the client as the mixers were run regularly and had very little idle time.

1. Mixer with old seal around the base.
2. Underside of the mixer showing water ingress from above.
3. New seal, using Belzona 3121.
