STRENGTHENING CORRODED STORAGE TANK WITH BELZONA

A carbon steel storage tank (18m in diameter and 11m high) on a chemical plant, for EDC storage.

Numerous areas of the tank had a loss of thickness due to corrosion.

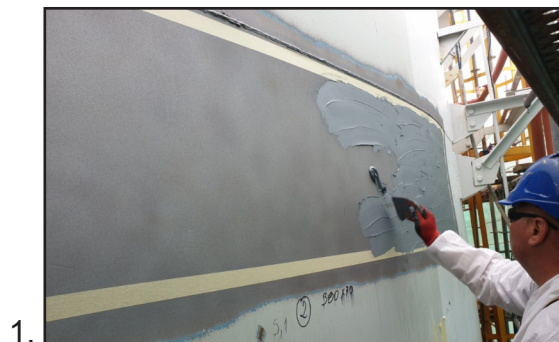
1. Rebuild defects using Belzona 1111
2. Wetted out substrate with Belzona 1981
3. Applied wetted out reinforcement sheet Belzona 9381 to repair area.
4. Consolidated finished application using Belzona 9382 before overcoating with Belzona 5811
