REGULATORY AGENCY ACCEPTS BELZONA SUPERWRAP II

Offshore platform with leaking pipe

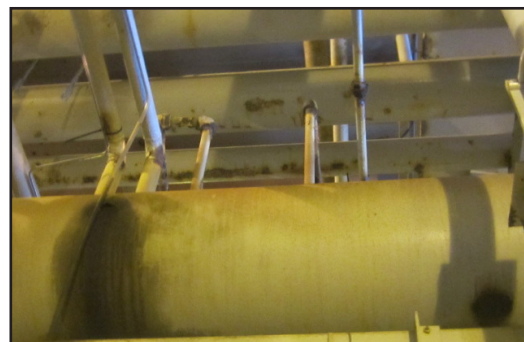
The customer had a section of pipe with external corrosion problems and several through wall defects. Traditional cut and replace alternatives would require costly shutoff of the platform. The entire pipe was welded in place and there were no flanged connections to make a spool swap. An engineered solution was required by the regulatory agency that oversees the platform.

1. Pipe section showing two leaks.
2. One of the hole-through defects.
3. Super Wrap II is applied to nozzles first.
4. Super Wrap II is applied to larger pipe.
