BELZONA PROVEN CAVITATION PROTECTION TO FRANCIS TURBINE

CUSTOMER
Poland

APPLICATION DATE
2019

The client required reconstruction of defects and chemical protection of the Francis Turbine Runner constructed in 1925 at the hydroelectric plant.

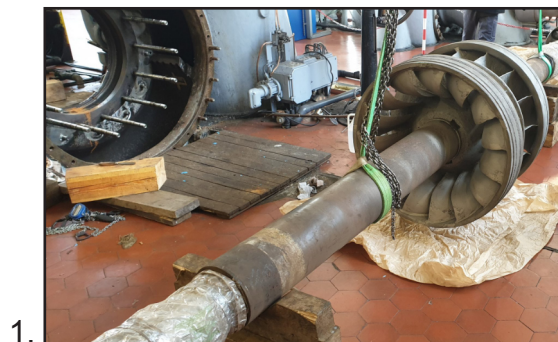
Cavitation has caused erosion of the parent metal and loss of performance of the turbine.

1. Turbine after grit blasting
2. Repaired with Belzona 1221
3. In Progress
4. Coated with Belzona 2141

The application was carried out in accordance with the Belzona Know-How System Leaflets CEP-3 and CEP-5. Firstly, metal loss was repaired with Belzona 1221. Once the damaged areas had been repaired, the turbine runners were completely coated with Belzona 2141.
