BELZONA REBUILDS NOT ONE BUT TWO 250-YEAR-OLD STONE STAIRCASES

Essex, UK

Aug-21

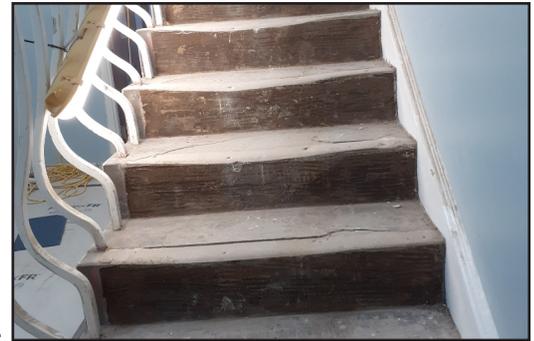
The first staircase was badly worn from 250 years of use, making them a health and safety concern. Some steps had worn up to 40mm in the centre. The second main feature curved staircase had previous historic repairs that had failed again also making this feature staircase a health and safety concern. Both staircases were built in stone with wrought iron balustrades.

1. Worn stone steps of upper staircase prior to application showing wear up to 40mm in the centre of the step.
2. Wooden shuttering in place steps conditioned and Belzona 4131 being applied.
3. The main staircase during application, showing the perforated mesh reinforcing sheet over the failed historic repair.
4. Upper staircase application completed awaiting covering and grip nosings.

The steps were worn smooth, therefore, the surfaces needed to be roughened with a grinder. Wooden shuttering, coated in Belzona 9411 Release Agent was laser aligned and installed to ensure the correct level to each step. Each step was then coated with Belzona 4911 TX Conditioner prior to the application of Belzona 4131 Magma Screed. The main feature steps had to be reinforced with perforated mesh as there was a 30mm overhang to be incorporated into the repair.
