BELZONA SUPER WRAP II REPAIR TO MAIN SEWAGE PIPE

Water Supplier, South of England, UK

Jun-18

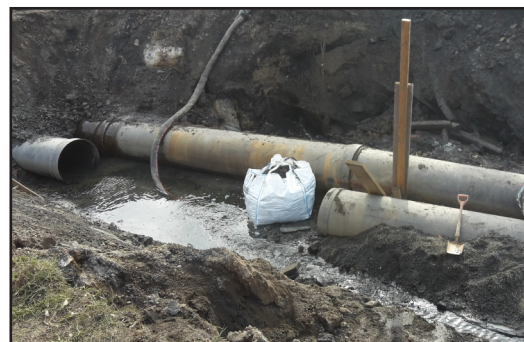
Following impact damage, the 800mm diameter, GRP sewerage pipe had cracked. The crack ran around the complete circumference of the pipe.

1. Cracked Sewage pipe
2. Belzona 1111 (Super Metal) repair
3. Release film applied
4. Three wraps of Belzona SuperWrap II
