## BELZONA REPAIRS CAVITATION DAMAGE TO THE BULK CARRIER PROPELLER BLADES

Propellers on bulk carrier had severe cavitation damage on all four blades of propellers.

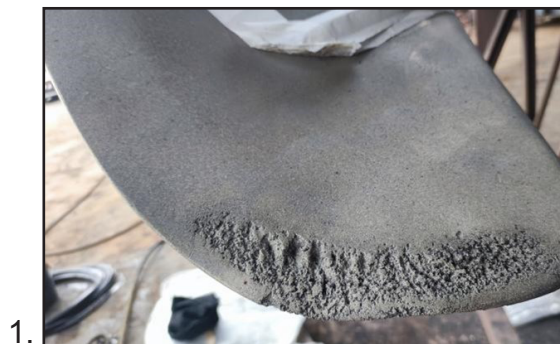
1. Surface preparation with sandblasting
2. Rebuilding metal loss with Belzona 1311
3. Cavitation prevention with Belzona 1321
4. Complete application
