BELZONA RELINES ABSORBER TOWER IN PETROCHEMICAL PLANT

MEA-CO₂ Absorber tower - 18m high, 2.3m diameter in Ammonia Plant

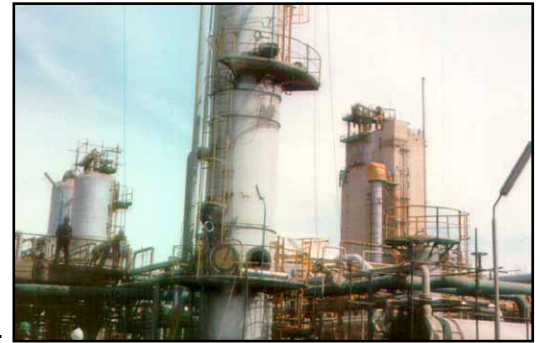
1. The absorber tower
2. Internal scaffolding erected and surfaces prepared
3. The repair in its final stages

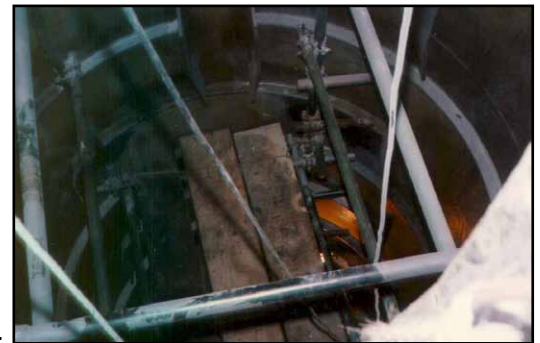
2.

Erosion of the tower lining by the fluids it contained had previously been repaired by the clients own staff. Surface preparation had not been sufficiently good and the repair had failed by peeling.

In accordance with Belzona Know-How System Leaflet TCC-5.
