BELZONA REPAIRS SUBWAY HANDRAIL

Subway Station in Quebec, Canada

Handrail of escalator at a subway station

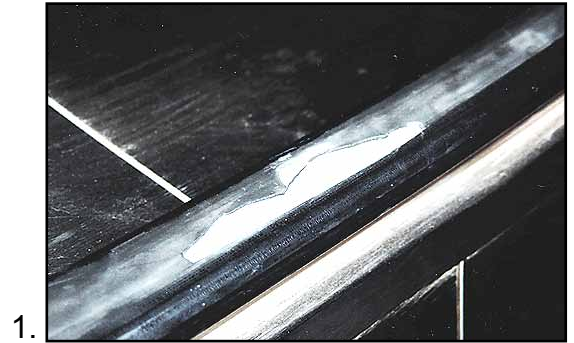
Due to vandalism, a chunk of rubber was missing from the handrail.

1. The damage due to the vandalism
2. Application of Belzona® 2311 in progress
3. The finished repair ready for operation
