BELZONA PERFORMANCE IMPROVEMENT PROGRAM (PIP) BOOSTS OUTPUT

Water Distribution Company

Water transmission pumping station

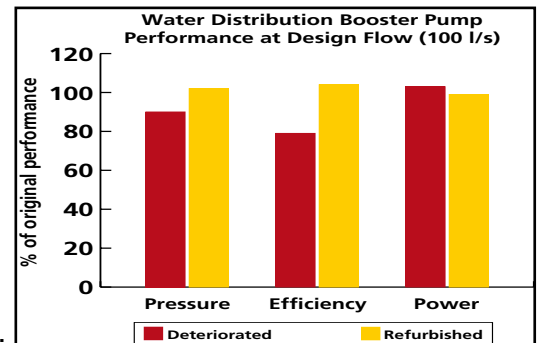
Due to the reduced output of the pump units and the increased demand for water, each unit was removed for inspection and repairs and coating were carried out in line with Belzona P.I.P. recommendations. The pumps were then tested prior to re-installation on-site where dramatic results of all five units were observed. Under normal demand only three pumps are required instead of five. Flow has increased from 65 liters/sec. to 125 liters/sec. at the required pressure. Power consumption was reduced by 5%. Pump efficiency increased by 24%.

1. Pump house showing pump unit
2. Performance improvement information
3. The completed application following refurbishment
