## BELZONA REPAIR TO DIAPHRAGMS IN STEAM TURBINE

Power Plant in Indianapolis

Diaphragms in steam turbine

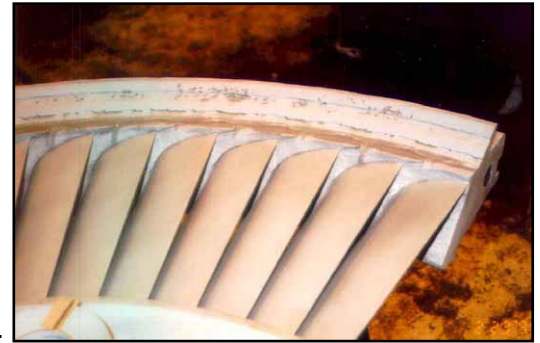
Severe erosion/ corrosion of the turbine diaphragms in the the latter stages of the low pressure side of the steam turbine. This had been caused by many years exposure to saturated steam and had resulted in a decrease in efficiency in the turbine.

1. Erosion damage on the diaphragm
2. Application of Belzona® 1311 to restore profiles
3. Application of Belzona® 1391 underway

Modified versions of Belzona Know-How System Leaflets CEP-5 and CEP-3. Belzona® 1311 was used to rebuild the damaged areas. Sites rebuilt were then treated with two coats of Belzona® 1391.
