## BELZONA SAVES AGRICULTURAL CHEMICAL COMPANY \$3 MILLION

10 ft. diameter x 12 ft. long filter drum used to manufacture Aureomycin

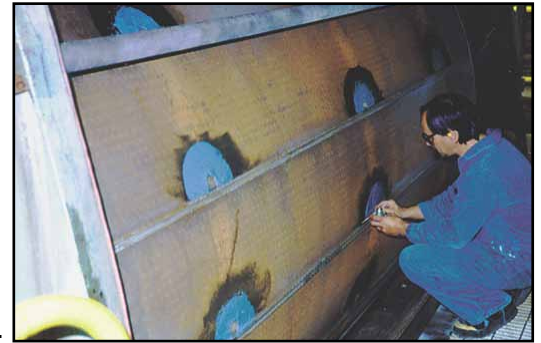
1. Belzona® 1221 around pipe, Belzona® 2311 on the drum around the Super E Metal patch
2. Beginning Belzona® 2311 patches
3. Completing Belzona® 2311 over Belzona® 1221

Leaks developed at the welds joining the vacuum lines to the face of the drum. The inside diameter of the drum was so deteriorated that there was some flexing at the drum face.

After six weeks, the customer decided to check the repairs, believing that they were probably beginning to fail. Six repair areas were ground off, and no problems were observed. They were re-done as before, and the drum returned to service, saving the company over \$3 million.
