## MULTIPLE BELZONA REPAIRS TO 72” DIAMETER STEEL PIPE EMBEDDED IN CONCRETE

Nuclear Power Plant in New Jersey

Service water system piping (condenser outlet pipe to cooling tower)

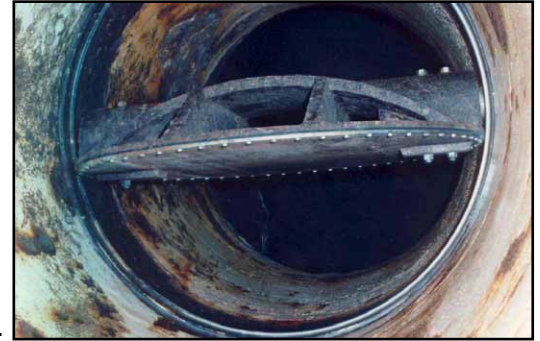
The 72” diameter steel pipe embedded in concrete was corroded and had developed through wall leaks.

1. View of the eroded pipe before work commenced
2. Completed application to steel pipe
3. Overall view of repair area showing patch repairs to concrete pipe and application to steel pipe in background
