BELZONA BUSHING REPAIR WITH BELZONA® 1111

Caterpillar 96°C Loader

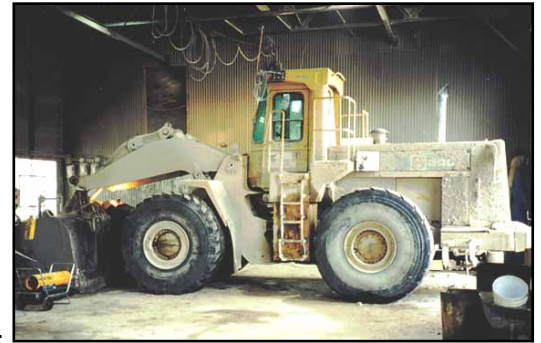
1. Cat 960 loader
2. Mandrel being inserted into the right hand bore to make the repair
3. Left side bucket pin installed and alignment pin removed
