BELZONA SAVES MONEY ON THE REPAIR OF A TRUNNION

Steel Mill in British Columbia

Trunnion bearing

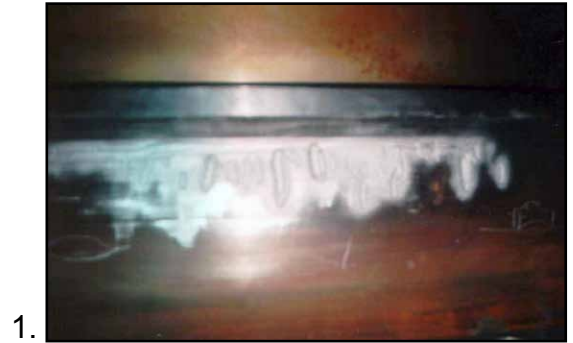
The seal area of a trunnion bearing had been badly scored by the ingress of foreign matter behind the seal.

1. Damaged seal area
2. View of trunnion bearing
3. Repair successfully completed

Belzona® 1111 (Super Metal)

In accordance with Belzona Know-How System Leaflet MPT-3.
