## BELZONA REPAIRS HYDROGEN COOLERS AND PIPING

Power plant in Texas, U.S.A.

Erosion-corrosion on hydrogen coolers and piping

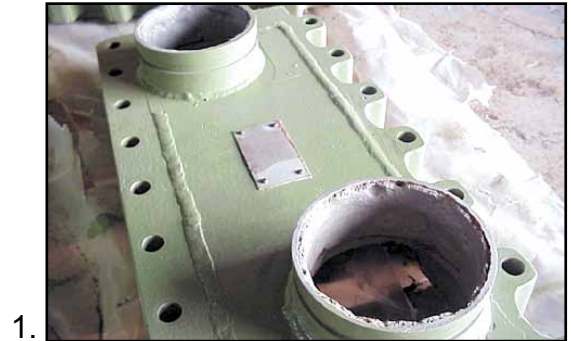
1. Close-up of erosion-corrosion in hydrogen coolers.
2. Erosion-corrosion in hydrogen piping.
3. Cooler heads being rebuilt with Belzona® 1121.
4. Finished pieces overcoated with Belzona® 1341.
