BELZONA PROTECTS LIKE NO OTHER

Chemical manufacturing company, Florida - USA

Protect new containment for concentrated acid storage tanks

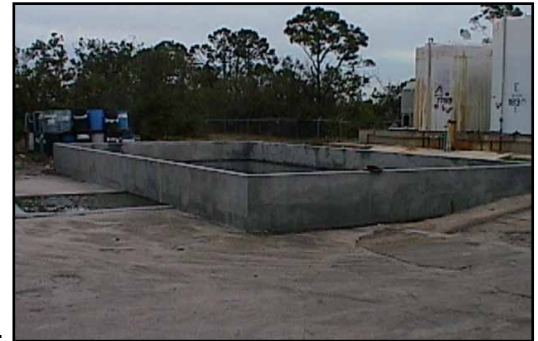
1. General view of the area
2. Belzona® 4911 and Belzona® 4141 applied
3. Belzona® 4311 coat interrupted
4. Belzona® 4311 applied over night, completing the application
