## KEEPING THE RAIN OUT WITH BELZONA EXPANSION JOINTS

Local Authority, St.Helens, UK

Vertical and horizontal expansion joints in asphalt floor and brick walls of shelterd housing complex.

Leaking expansion joints

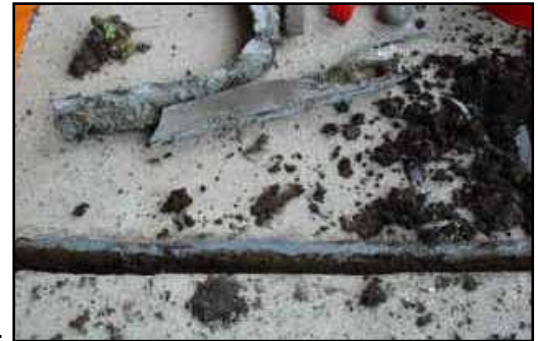
1. Old joint being scraped out
2. Joints masked off ready for re-filling
3. The completed repair
4. An external 7-meter vertical expansion joint

The old expansion joints were not flexible enough and were allowing rainwater to seep through into the neighboring dwellings causing damp problems. The joints were removed and filled using Belzona® 4521 for the horizontal joints and Belzona® 2211 for the vertical. A layer of Belzona® 2211 was also applied over the horizontal joints to improve the aesthetics of the repair.
