BELZONA: STOPS LEAKS IN COOLING TOWERS

Power Plant in South Texas

Cooling tower basin

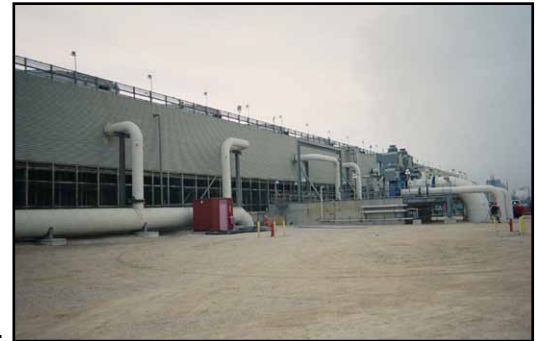
1. Cooling tower
2. Expansion joints being prepared
3. Belzona® 2221 being poured into backed joints
4. Finished joint holds back rainwater

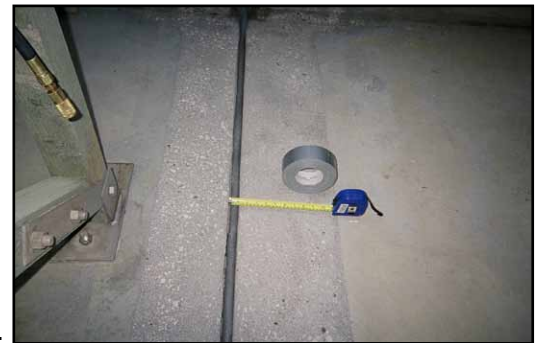
Leaking water was causing economic concerns. The old joint sealants had worn down and ground movement caused leaks in the concrete floor and walls.
