BELZONA PROTECTS CONDENSER TUBE SHEET

Power plant, Egypt

Steam unit condensers at a large power station.

Corrosion of the tube sheets of two condensers.

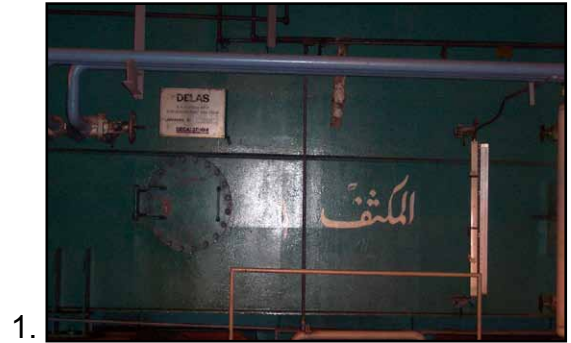
1. General view of the Condenser
2. The corroded tube sheet
3. Applying Belzona® 1321 to the tube sheet
4. Completed application
