MAKE HAY WHILE THE SUN SHINES

Damaged obsolete U.S. Royal 5.50-16 implement tread tire from J.I. Case 140w hay baler.

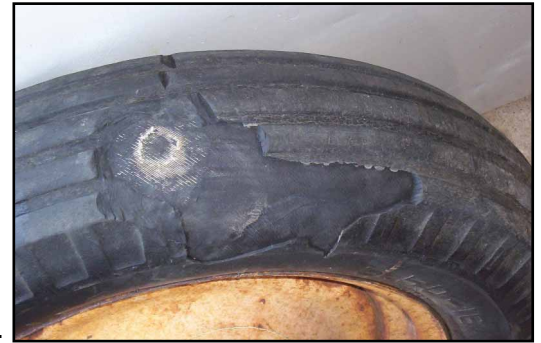
Tire was damaged but cords still in good condition. No replacement available.

1. Damaged tire.
2. All loose rubber removed from tire.
3. Release agent was applied to a mold. Belzona® 2211 was applied to the tire and mold.
4. The tire repaired.
