BELZONA REPAIR BY ROPE ACCESS

Offshore Platform, Indonesia

8-inch diameter Neoprene coated Riser Pipe

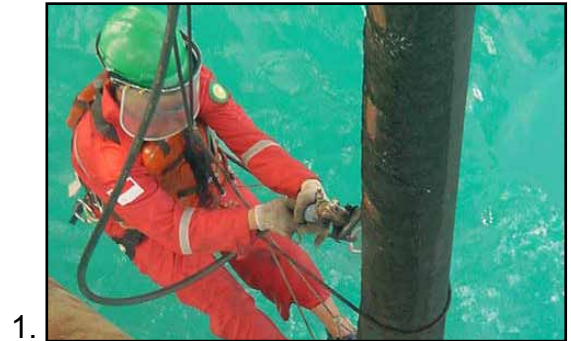
Damage on Neoprene coating and corrosion in splash zone.

1. Preparation of existing Neoprene
2. Rebuild and coating with Belzona® 2211 and Belzona® 2121
3. Coating splashing zone with Belzona® 5831
4. Complete application

Application carried out in accordance with modified Belzona Know-How System Leaflet VPF-3. Existing Neoprene repaired and coated with Belzona® 2211 and Belzona® 2121. Splash zone protected with Belzona® 5831.
