BELZONA REPAIRS CONVEYOR BELT WITH MINIMAL DOWNTIME

Pulp mill in Florida U.S.A.

PVC conveyor belt lap joint.

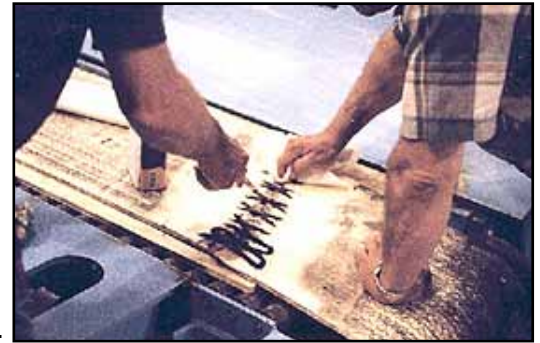
1. Cleaning and degreasing conveyor belt, lacing in place
2. Applying Belzona® 2311
3. Finished application with belt in service
