BELZONA KEEPS CHEMICALS CONTAINED

Pulp and paper mill in Mississippi, USA

Chemical containment floor of a sulfuric acid mixing station.

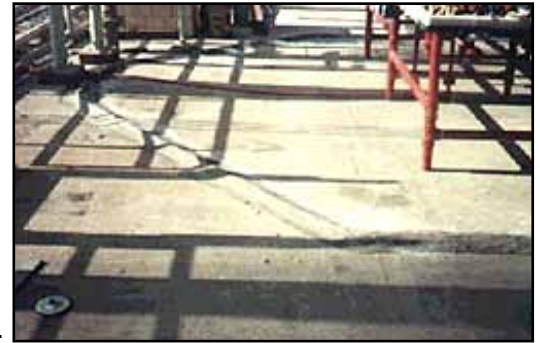
Sodium sulfate as well as some sulfuric acid is used to control the pH as well as sulfur content in the cooking liquor. This sulfuric acid mixing station suffered from acid deterioration and actually contaminated the paper making stock below.

1. Deteriorated sulfuric acid mixing station floor
2. First coat of Belzona® 4311
3. Finished application
