BELZONA REPAIRS A HOLE IN THIS HOPPER DREDGE HOSE

Hopper dredge hose.

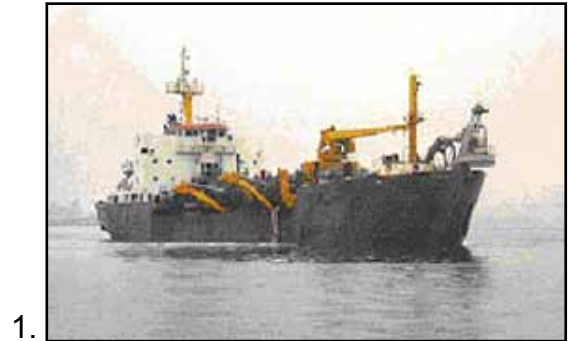
A hole in the hose was caused from large volumes of abrasive solids passing through it.

1. View of the Dutch dredge ship
2. Hopper dredge hose being inspected
3. Extensive damage evident
4. Area being rebuilt with Belzona® 2311

Belzona® 2111 (D&A Hi-Build)
Belzona® 2311 (SR Elastomer)

The application was carried out in accordance with Belzona Know-How System Leaflet SOS-12.
