## BELZONA EXPANSION JOINTS: TOUGH ENOUGH FOR HEAVILY TRAVELLED HIGHWAYS

Kentucky DOT (Department of Transportation) - U.S.A.

Bridge expansion joints on Interstate 65.

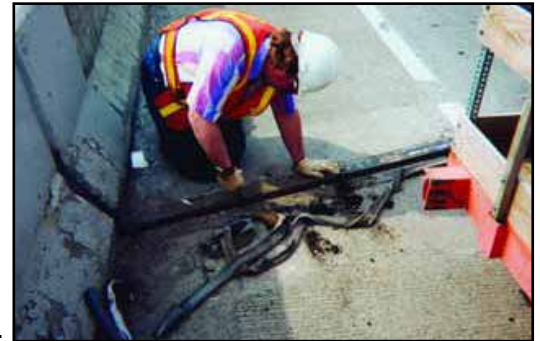
The conventional expansion joints were too soft and could not withstand typical road debris. They were failing after less than one year.

1. The failed joint is easily removed thanks to poor adhesion
2. The surface for the new joint is prepared
3. Backer rod inserted
4. The application is complete and ready for vehicular traffic
