BELZONA AIR HANDLING FAN & SHROUD

Steel Company - Hamilton, Ontario - Canada

Air Handling Fan

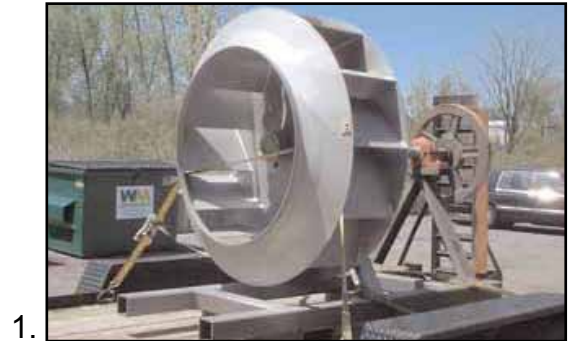
Fan was constantly going out of balance due to particulate sticking to the blade.

1. Fan blasted to 3-4 mil profile, white metal finish
2. Second coat of Belzona® 1341 completed on fan
3. Shroud coat completed

The Application was carried out in accordance with Belzona Know-How System Leaflet FBC-2.

The fan was dynamically balanced before and after the application.
