BELZONA EXCELS WHERE OTHERS FAIL!

Forging Machine Cam

Forging machine cam failed, imitator product failed in one week.

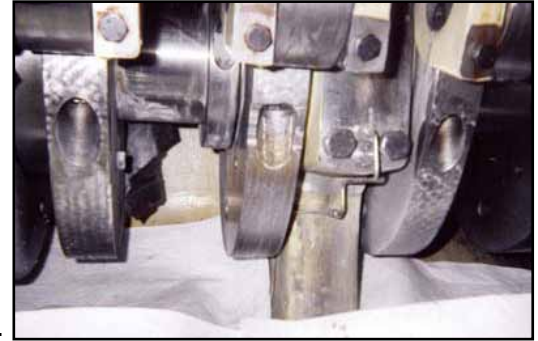
1. The Cam
2. Products being used
3. The completed application

The application was carried out in accordance with a modified version of Belzona Know-How Systems Leaflet MPT-12. Damaged areas were ground down. Following degreasing, Belzona® 1111 was applied, then ground/sanded back to profile.

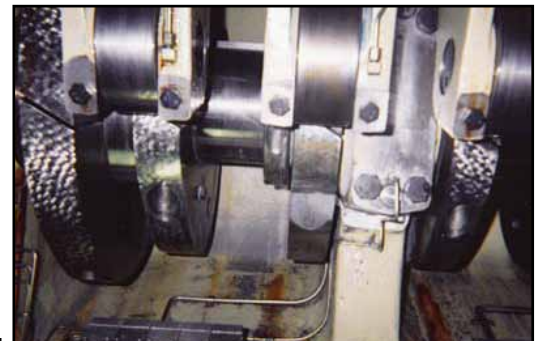
Application saved tens of thousands of dollars in downtime, as disassembly of machine takes four days. Four months in service - PERFECT!
