## CLASSIC BELZONA PUMP REFURBISHMENT-OUTPUT INCREASES 9.5% AFTER 3½ YEARS

National water supply company in Tunisia

Two badly corroded/cavitated centrifugal KSB water supply pumps.

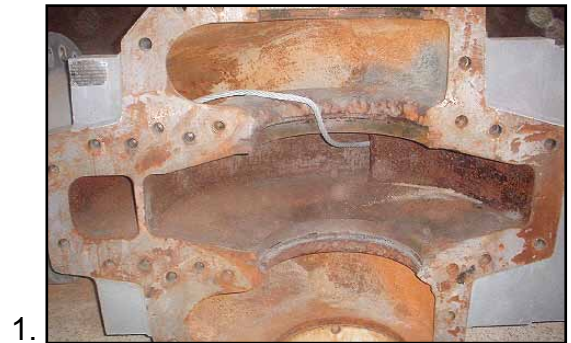
Output from the pumps was drastically reduced from the new condition due to corrosion and cavitation damage.

1. Damaged pump
2. Neck ring seats restored to original sizes
3. Complete repair
4. Coating in good condition after 3-1/2 years of service

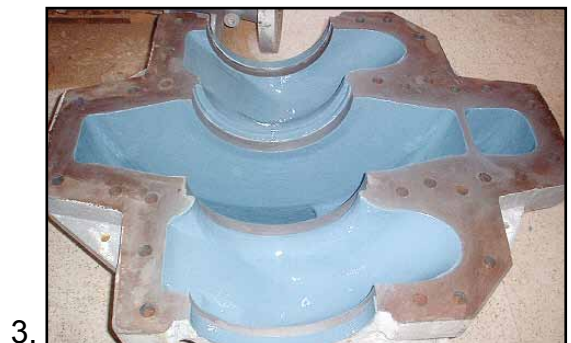
Flow rate of New Pump - 540 L/sec (142 gal/sec) Flow rate of damaged pump - 480 L/sec (126 gal/sec) Flow rate of repaired pump - 540 L/sec (142 gal/sec), an increase of more than 12% over the corroded pump. After 3-1/2 years, the flow rate of the repaired pump is 530 L/sec (140 gal/sec), an increase of more than 9.5% over the corroded pump.
