BELZONA PROTECTION INSIDE AND OUT!

Portable Acid Tanks for Oil Well Injection.

PROBLEM

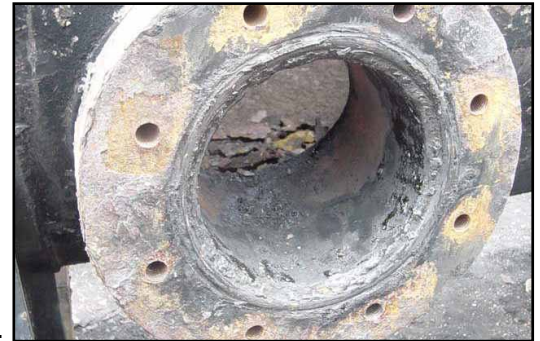
Internal corrosion due to contact with HCL (hydrochloric acid) 30-36% had caused severe corrosion on the walls, nozzles, fittings, etc. of the tanks. The exterior of the tanks had been damaged from atmospheric corrosion.

1. Extent of the corrosion due to the effects of the hydrochloric acid coupled with hydrocarbons and heat.
2. Nozzles coated with Belzona® 4311 or Belzona® 4341, depending on operating temperatures.
3. Pinhole detection being carried out over the Belzona coating system.
4. Exterior view of the tank coated on the outside with Belzona® 6111/Belzona® 5111.

Failure of vinyl ester coating forced customer to bring the tanks out of operation every 4-6 months. The Belzona solution allowed for the rebuilding of the damaged areas with Belzona® 1111. Depending on the operation temperatures of the tanks, either Belzona® 4311 or Belzona® 4341 was used as the coating material. Belzona® 6111/5111 was used on the exterior of the tanks.
