## BELZONA® 5851 ON OFFSHORE PIPEWORK

Corrosion Under Insulation (CUI) on heating medium pipework.

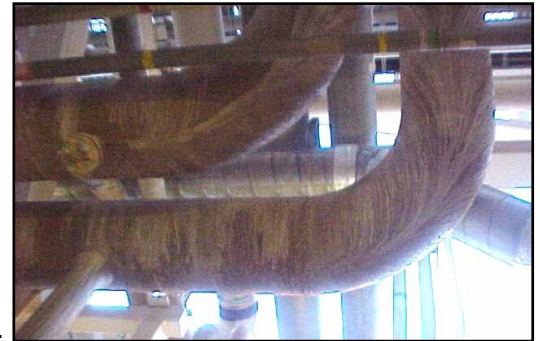
The presence of insulation around the heating medium pipework had let to some corrosion of the pipework over a period of time. During a routine inspection it was decided that applying Belzona® 5851 whilst the pipework remained in service represented the best option to prevent future corrosion.

1. Corrosion to heating medium pipework
2. Application of first coat of Belzona® 5851
3. Completed application
