BELZONA PREVENTS GALVANIC AND CREVICE CORROSION ON RUDDER HORN

Corrosion to internal of rudder horn of 280,000 Ton VLCC (Very Large Crude Carrier) required re-fixing of bearing.

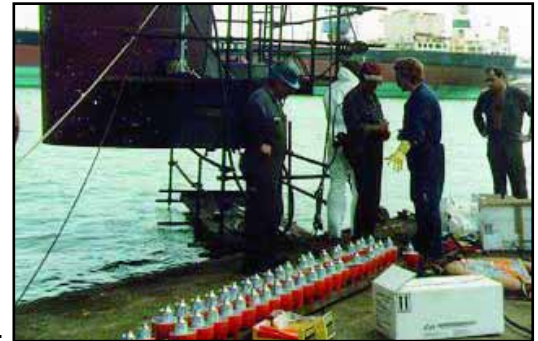
1. Belzona materials and team prepared for application.
2. Internal shot of bearing. Note arrows for injection ports.
3. Bearing after injection and prior to cleaning up of the Belzona® 1211 seal.

The bearing was aligned and its position in the housing fixed using alignment bolts. The top and bottom of the housing were sealed using Belzona® 1211, then Belzona® 1321 was injected from below.

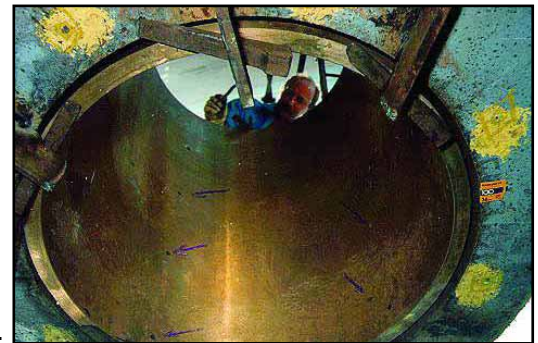
Corrosion to internal of rudder horn had allowed the press fitted bronze bearing to become free. Bearing was approximately 908-mm (36-inch) diameter and 1050-mm (41-inch) long.
