## CLASSIC TAIL SHAFT WRAP WITH BELZONA

Tail shaft for Fleet Auxiliary Ship

Tough corrosion protection required on exposed section of tail shaft.

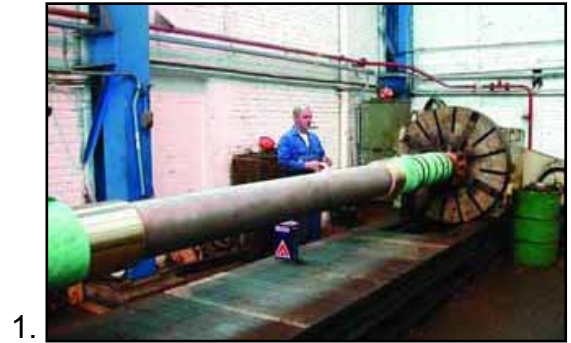
1. Shaft grit blasted and set up in lathe ready for start of application
2. Belzona® 1321 used to provide a secure termination to the application as termination grooves were not permitted
3. First coat of Belzona® 1321 applied incorporating Belzona® 9341
4. Completed application after application of second coat of Belzona® 1321.
