BELZONA REFRUBISHMENT OF COOLING WATER PUMP DIFFUSER

Power station in Egypt

Diffuser and bell-mouth from main cooling water lift pump.

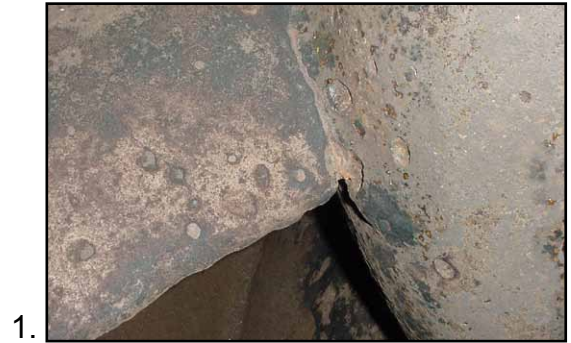
Severe erosion-corrosion.

1. Severity of erosion clearly evident
2. Surface preparation by grit blasting
3. Erosion rebuilt using Belzona® 1311
4. Coating with Belzona® 1341 underway
