BELZONA REPAIRS CEMENT BALL MILL

Cement works in Egypt

May 2001

Ball mill used to grind ingredients for cement production.

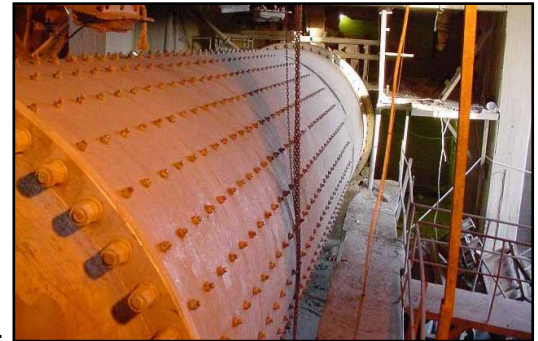
1. General view of the ball mill
2. Damage to mill barrel being indicated
3. Application of Belzona completed. Wear plates will be bolted in over the repair.

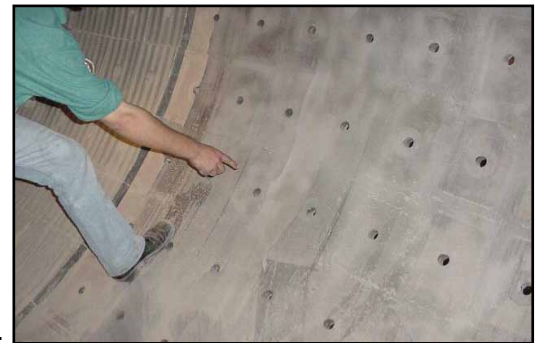
2.

Wear had occurred on the housing due to breakage of lining tiles which leads to direct impact of milling balls with barrel.

Belzona® 1111 restored the original dimensions using a simple former in a fraction of both time and cost. A conventional approach to repairing this problem - welding - was not an option due to the large size and difficulty of machining.
