BELZONA REPAIR STILL IN PLACE AFTER NINE YEARS & MILLIONS OF PASSOVERS

Missouri Department of Transport - USA

Big pothole in busy concrete interstate highway.

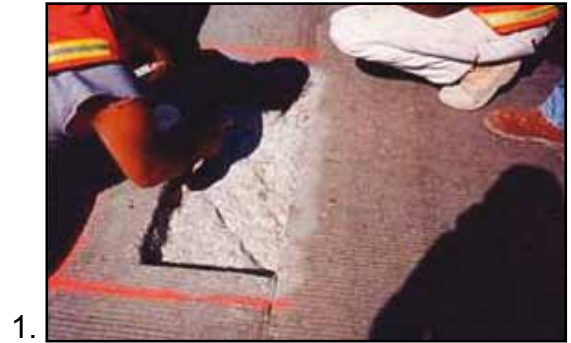
1. Final stages of surface preparation
2. Belzona® 4131 down; ready for next phase
3. Belzona® 4111 applied
4. External heat apparatus to speed up the lane opening

This nine-year-old application is on the busiest stretch of interstate in the state of Missouri - linking St. Louis with Kansas City. The ragged edges and spalled concrete were cut out. Belzona® 4131 was used to fill in the hole, topped off with 1/4"-inch of Belzona® 4111. The application area was then covered with concrete blankets and heated with a gas-fired portable heater. External heat was applied for 50 minutes at 180°F, allowing the lane to open less than four hours later. It's still there today.
