THERE'S NOTHING FISHY ABOUT THIS BELZONA REPAIR

Fishing boat

Cracked engine block

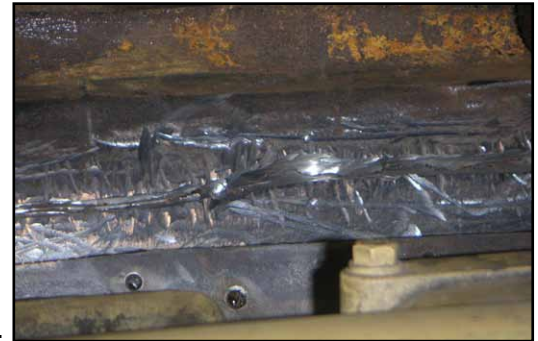
Cooling water froze due to lack of anti-freeze causing the engine block to crack.

1. Engine block after surface prep.
2. Belzona® 1111 applied. Metal bars are used to stabilize crack.
3. Installing metal bars.
4. More Belzona® 1111 applied to cover and protect the metal bars. Job completed.
