LONG LASTING BELZONA STEP REPAIR - EXCELLENT AFTER 20 YEARS

U.S. Air Force Base - Illinois U.S.A.

Steps into busy headquarters building

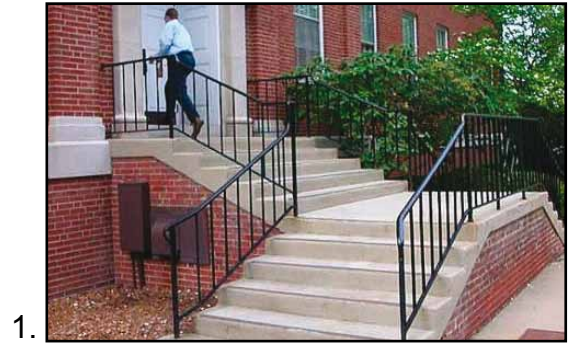
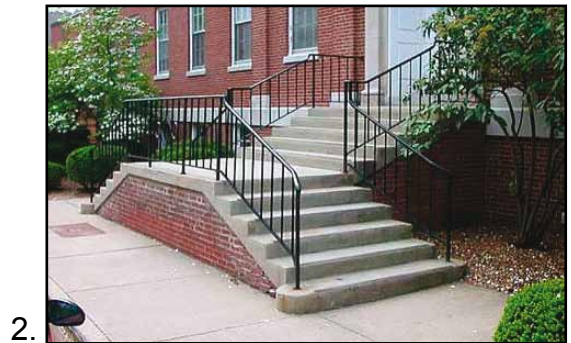
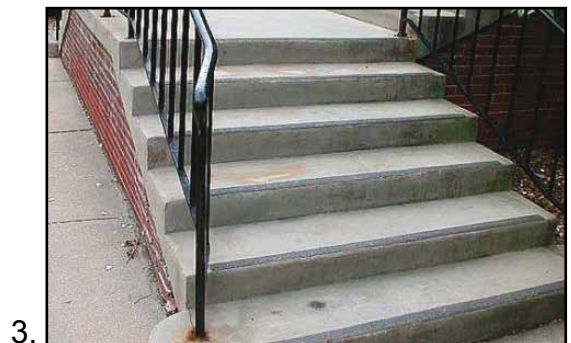
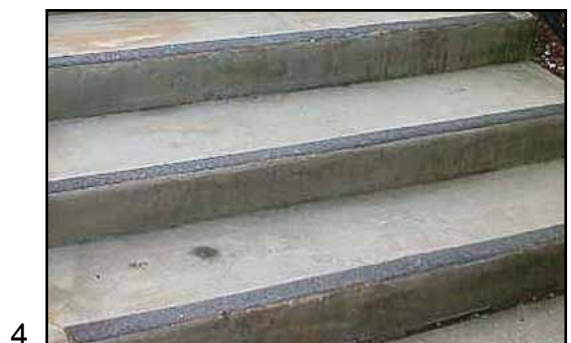
1. to 4. Various angles of the steps.

All the steps and landings were rebuilt/coated with 1/4" of Belzona® 4111. Strips of Belzona® (Ceramic S-Metal) and coarse aggregate were applied for safety. Repouring of the steps would have been very expensive and most likely would have suffered the same problem after a period of time. After 20 years the steps and the non-skid are still in excellent condition. The photos were taken in April of 2004.
