BELZONA SAVES AUTO INDUSTRY A CHUNK OF CASH

Auto Manufacturing Plant in Missouri, U.S.A.

Worn cylinders - welding robot control

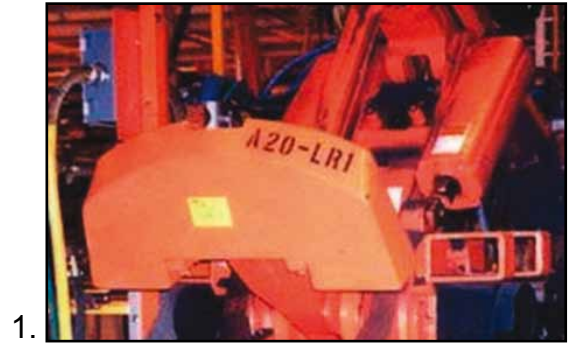
1. Equipment - welding robot
2. Worn cylinder
3. Almost there
4. Completed job

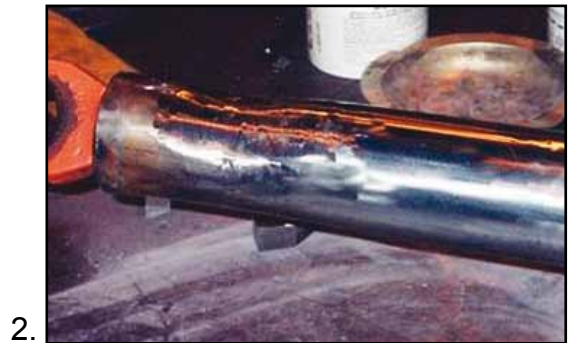
Welding robot control cylinder is simply a spring loaded shaft inside a housing. It controls the movement of the welder to and from the work - (slow going in, very quick return). Once the cylinders became worn, like the one in the photo, the whole assembly was replaced at a cost of \$3,500. The Belzona in-situ repair cost less than 5% of the replacement. There are 400 welders in the production line with two cylinders each.
