## NON-SLIP SAFETY SYSTEM IN HOSPITAL DISH WASHING ROOM

Regional Hospital - British Columbia, Canada

Hospital dish washing room floor

Inferior non-slip safety system

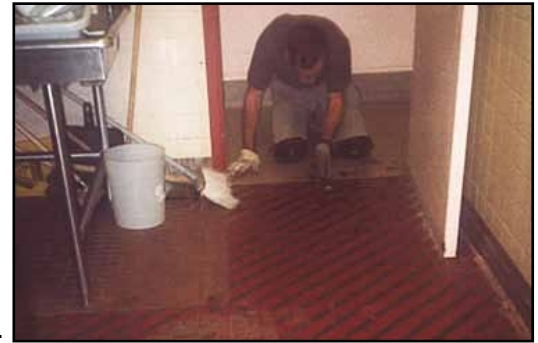
Customer had contracted with another vendor to apply a non-slip safety system to the dish wash room floor. However, soon after completion of the application, it was found that the surface was extremely slippery. Belzona was approached to apply our standard system over this coating. Within a few months the inferior coating started to delaminate. We were contracted to remove all the red coating and apply a Belzona safety grip system directly to the original floor tiles. Photograph shows removal in progress.

1. Previous failed system being stripped from the floor
2. View of application
3. View of another section of the application
