LARGE NON-SLIP SAFETY SYSTEM APPLICATION

Regional Hospital - British Columbia, Canada.

Safety system required in hospital kitchen, dishwashing room, and hallway. Total area completed approximately 1,400 square feet.

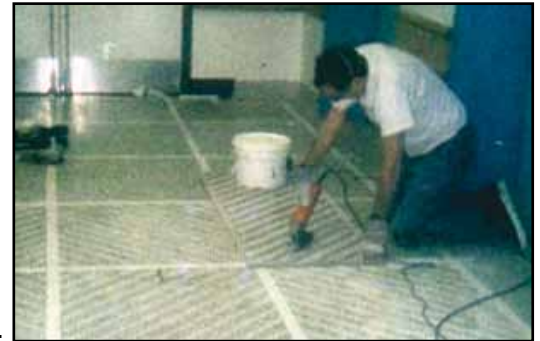
1. Preparation underway using a special silicon carbide grinding tool and template
2. Hospital opted for various different 'chevron' style patterns to help break up the areas
3. Another view of application with a different pattern
